Ocean Empire Diagnostic & Monitoring Group

INFRA RED/VIDEO ENG REPORT

NAME: Doe, John 6/15/66 BCBS
AGE: 45 GENDER: M
DATE: 07/03/11

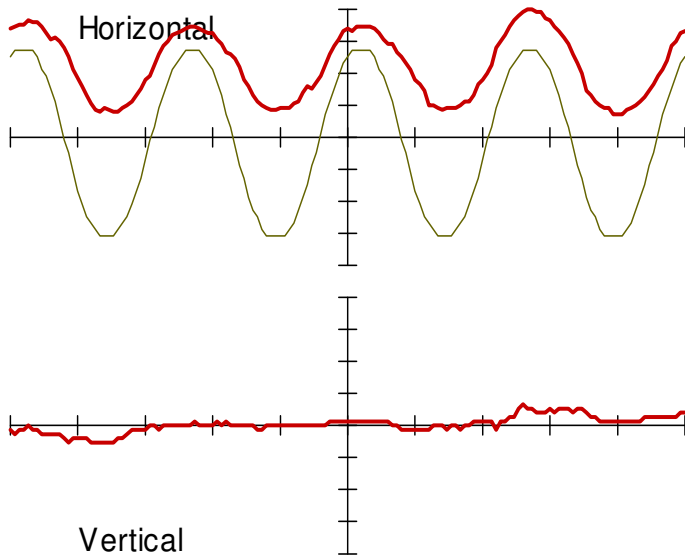
TRACKING .4 Hz

Gain 62%
Phase -15
Marked 'R' at 7 Sec.

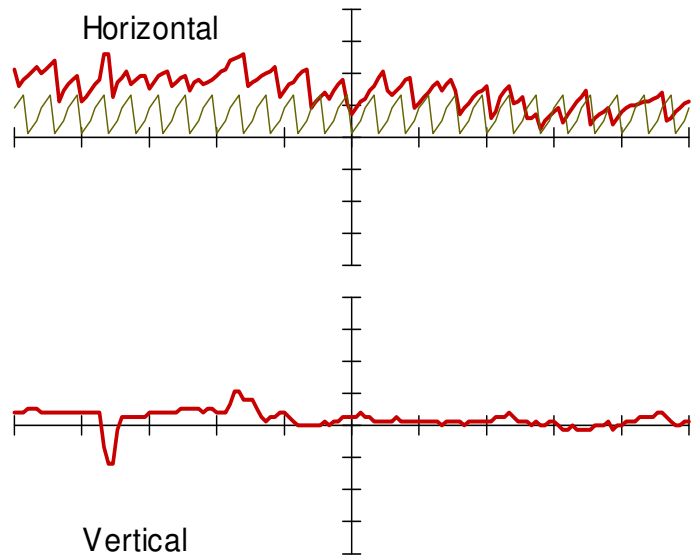
OPK RIGHTWARD

SCV
Horizontal 13L
Vertical 0
Marked 'R' at 8 Sec.

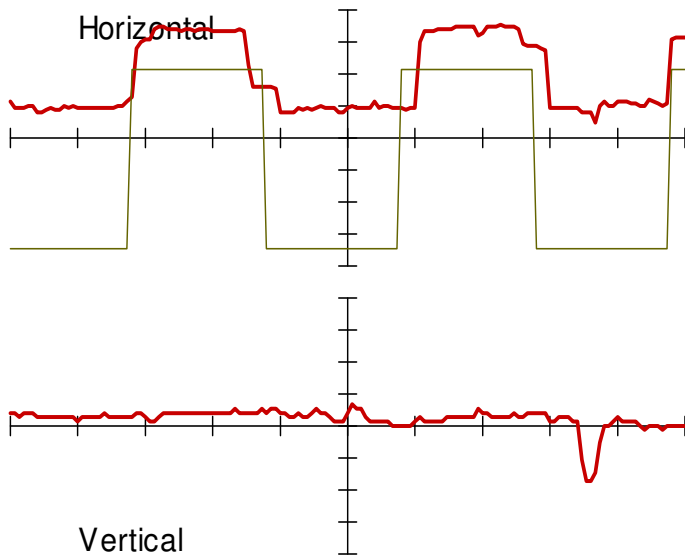
SACCADES

Velocity 280
Latency .233
Marked 'R' at 6 Sec.

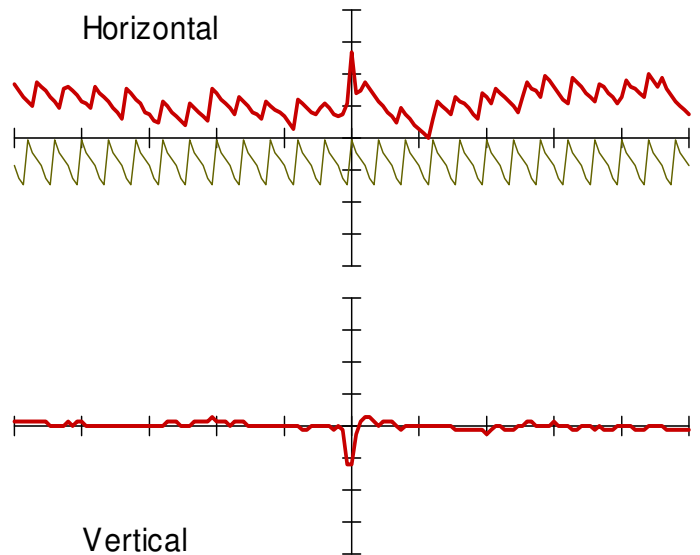
OPK LEFTWARD

SCV
Horizontal 12R
Vertical 0
Marked 'R' at 8 Sec.

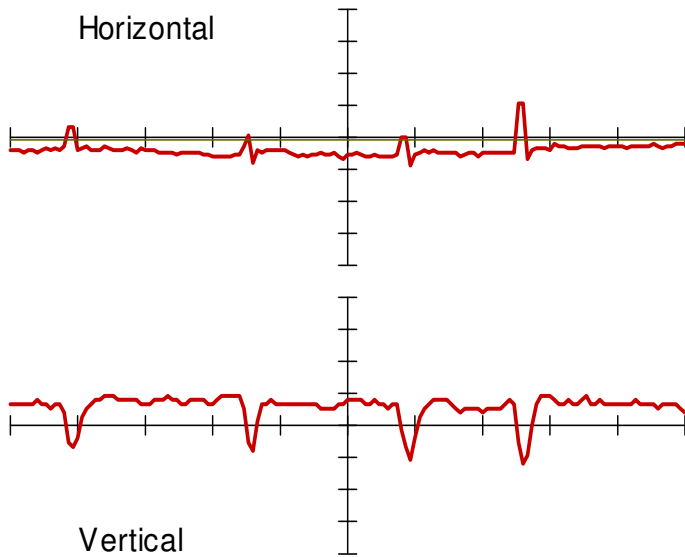
GAZE_LEFT

SCV
Horizontal 0
Vertical 0
Marked 'R' at 12 Sec.

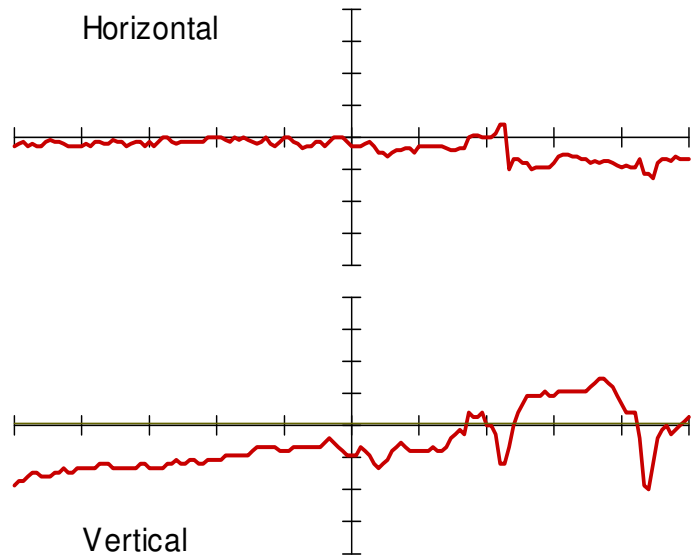
GAZE_UP

SCV
Horizontal 0
Vertical 2D
Marked 'R' at 12 Sec.

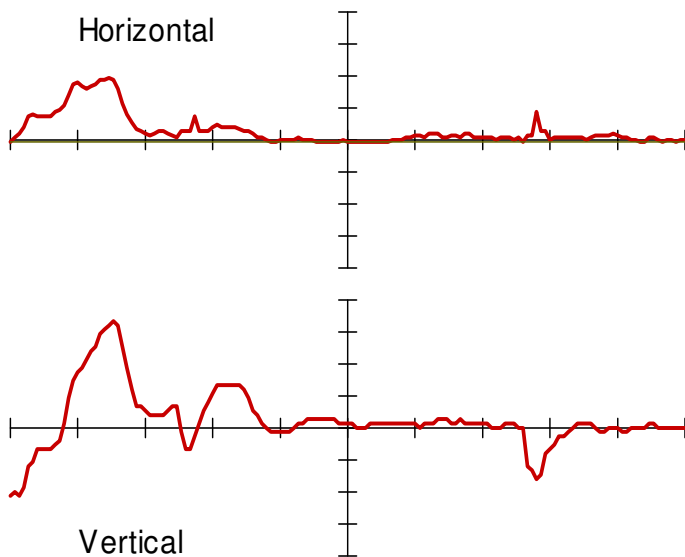
GAZE_RIGHT

SCV
Horizontal 0
Vertical 0
Marked 'R' at 10 Sec.

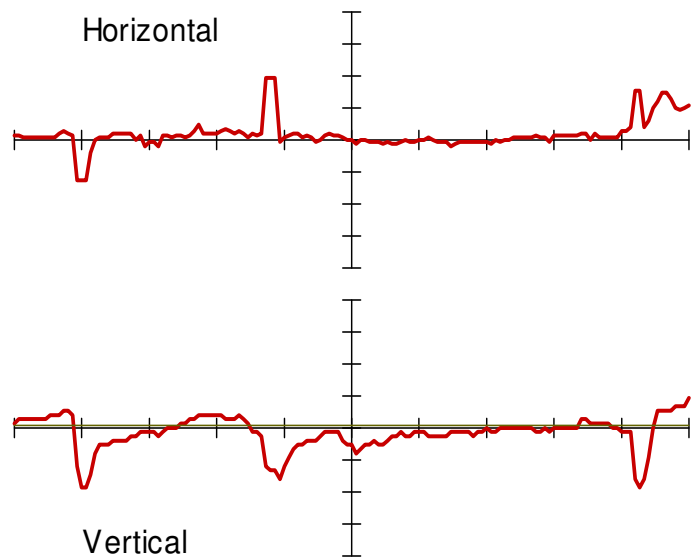
GAZE_DOWN

SCV
Horizontal 0
Vertical 1D
Marked 'R' at 12 Sec.

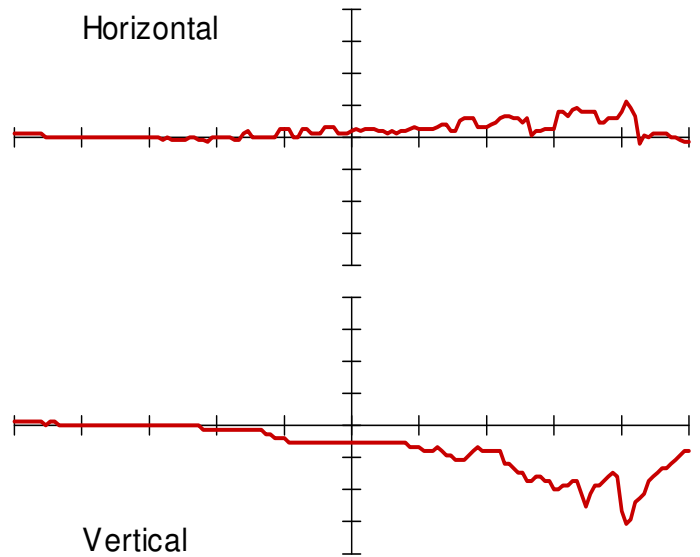
SPONTANEOUS

SCV
Horizontal 0
Vertical 0
Marked 'R' at 8 Sec.

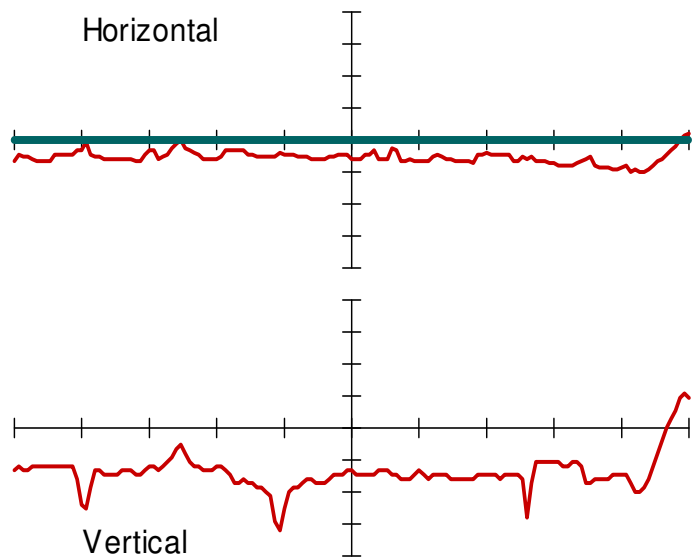
GAZE w /FIX.

SCV
Horizontal 0
Vertical 0
Marked 'R' at 17 Sec.

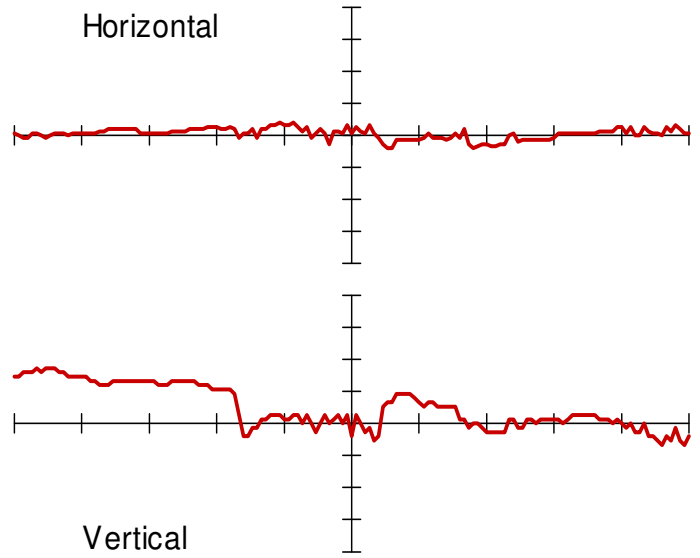
HALLPIKE RIGHT

SCV
Horizontal 0
Vertical 1U
Marked 'R' at 12 Sec.

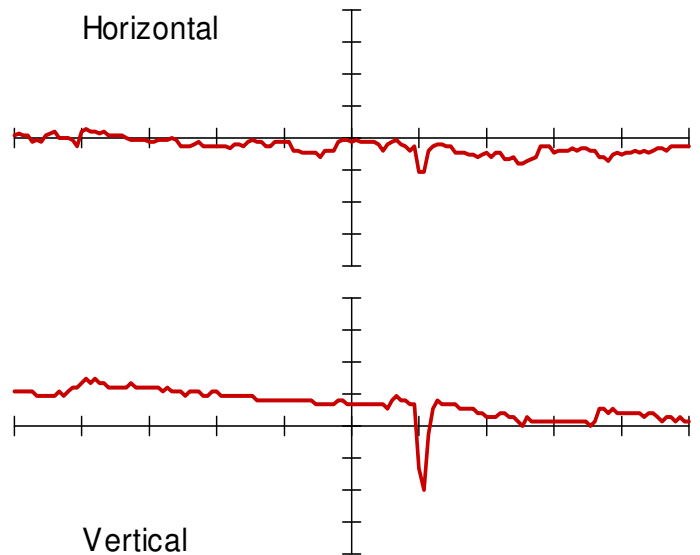
HALLPIKE LEFT

SCV
Horizontal 0
Vertical 1U
Marked 'R' at 9 Sec.

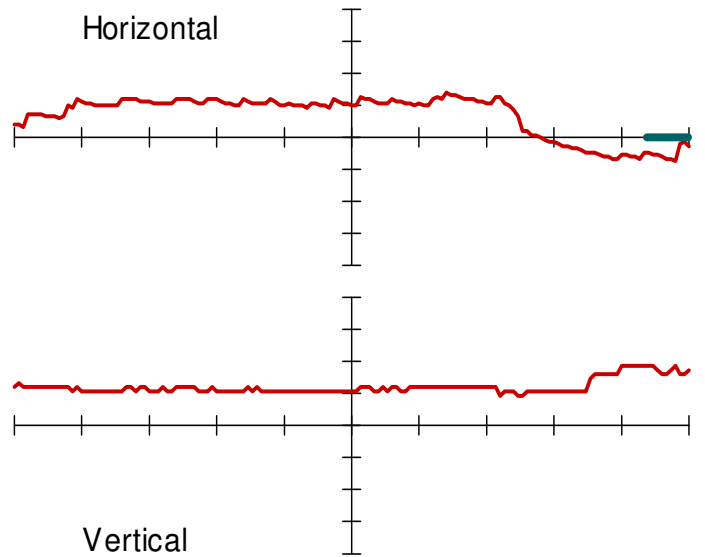
CAL COOL LEFT

SCV
Horizontal 2R
Vertical 0
Marked 'R' at 20 Sec.

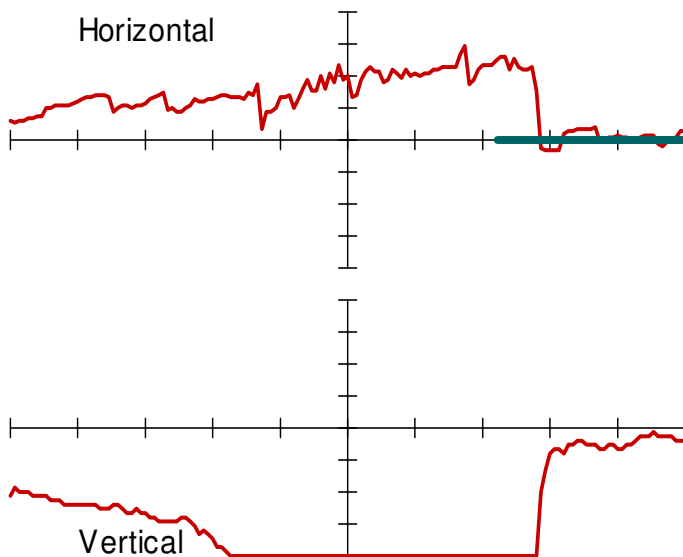
CAL COOL RIGHT

SCV
Horizontal 5L
Vertical 1U
Marked 'R' at 23 Sec.

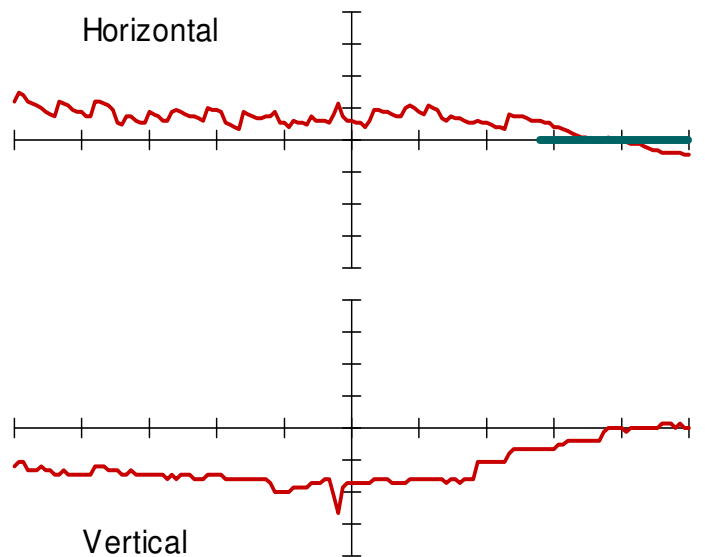
CAL WARM RIGHT

SCV
Horizontal 4R
Vertical 0
Marked 'R' at 21 Sec.

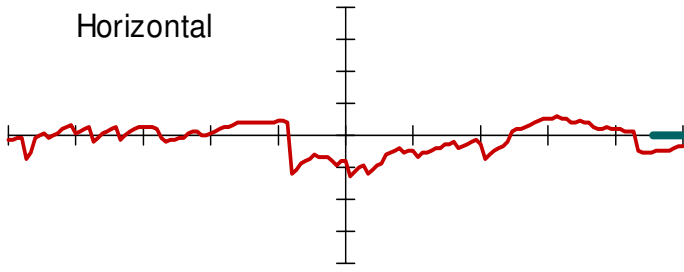
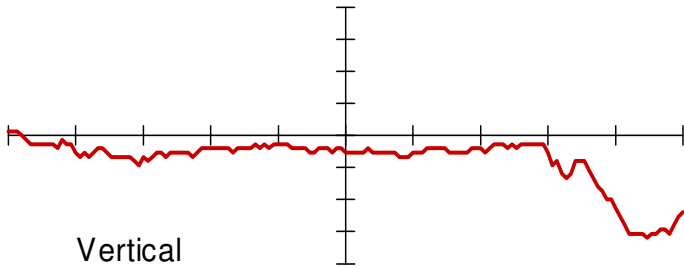
CAL WARM LEFT

SCV

Horizontal 4L

Vertical 0
